DEPARTMENT OF TRANSPORTATION

Federal Aviation Administration

[Docket No. 94-CE-28-AD]

Airworthiness Directives; Piper Aircraft Corporation PA-28 and PA-32 Series Airplanes

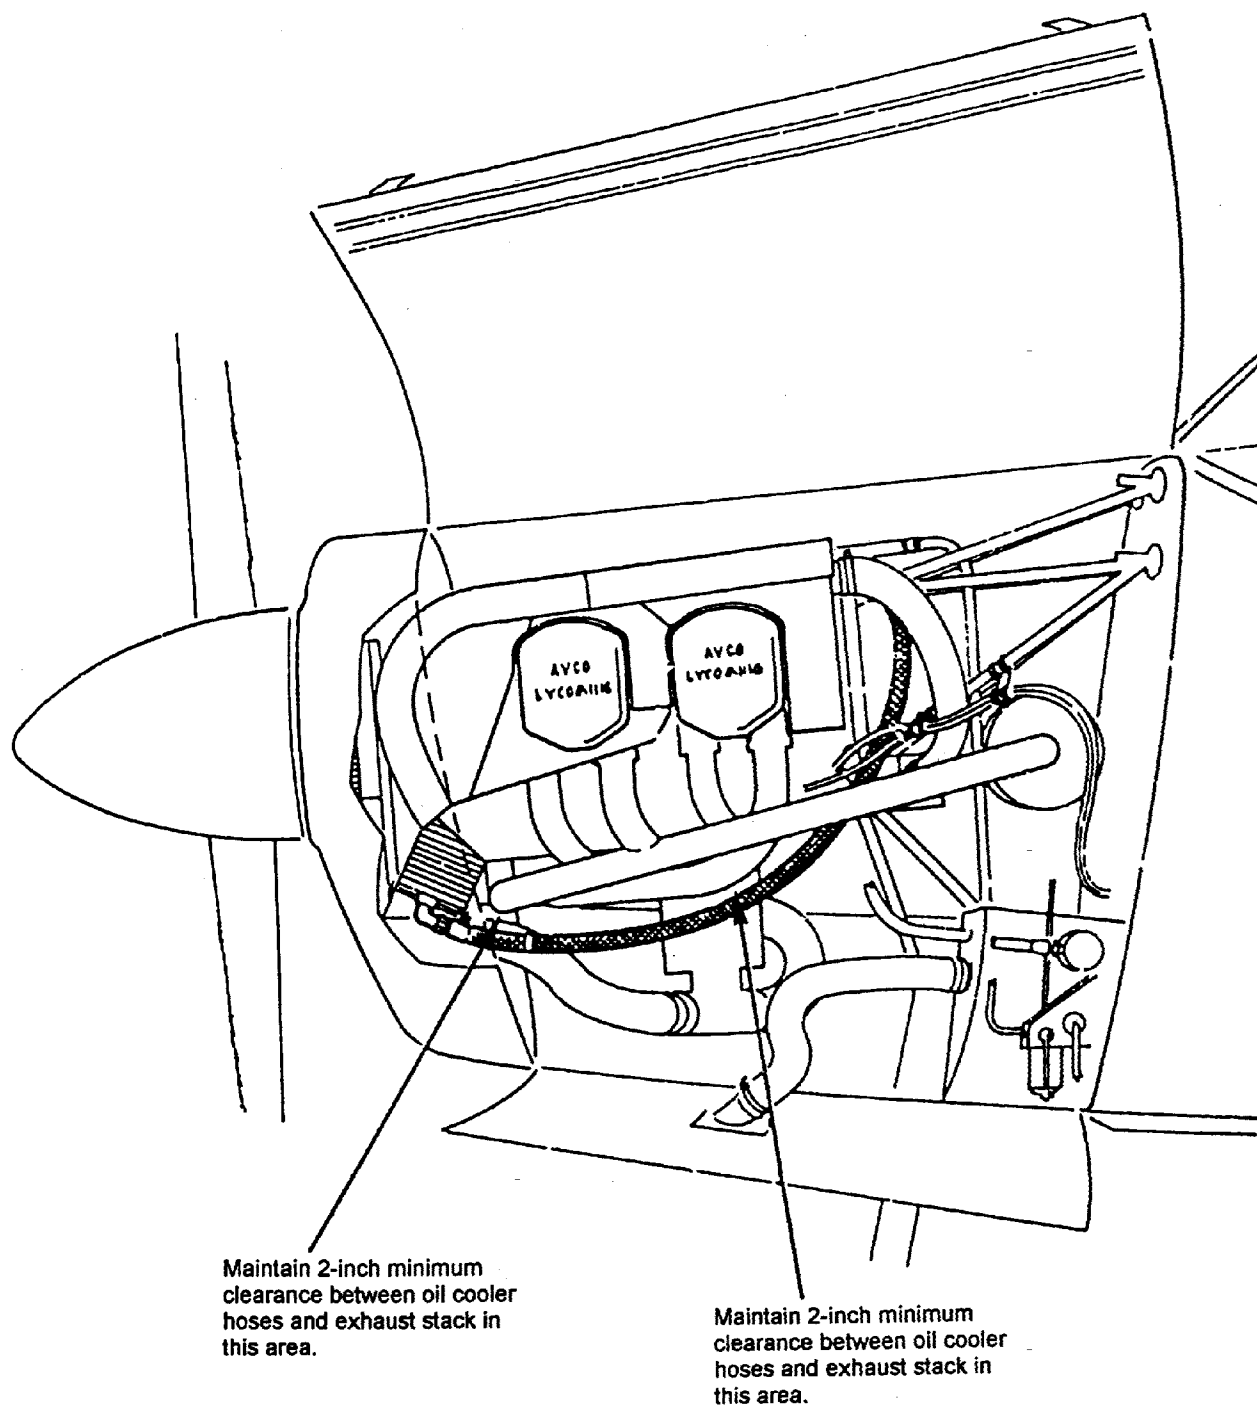
(2) On airplanes that have any oil cooler mounted in the front of the airplane, ensure that the following exists, and, prior to further flight, adjust accordingly:

(i) The hose passes underneath and behind the electrical ground cable and in front of the lower of the two engine mount struts when the hose is routed to the rear of the engine; and

(ii) The hose is tied to the engine mount strut and a clearance of at least 2 inches exists between the oil hose and exhaust stack.

Note 2: Figure 1 of this AD relates to the conditions specified in paragraphs (a)(2)(i) and (a)(2)(ii) of this AD.

(2) Replace the oil cooler assembly with an approved TSO-C53a, Type D, hose assembly ensuring that there is a minimum of 2 inches between the oil cooler hoses and exhaust stacks (as applicable) upon installation.

(d) After adjusting or installing oil cooler hoses, prior to further flight, run the engine for 5 minutes to ensure that there are no oil leaks and that the 2-inch clearance is maintained (as applicable) when the engine is warm. Prior to further flight, replace any leaking oil cooler hoses and adjust the clearance accordingly.
